**INVESTIGATION OF  
BUSHFIRE ATTACK MECHANISMS  
RESULTING IN HOUSE LOSS IN THE  
ACT BUSHFIRE 2003**

**Bushfire CRC Report**

**April 2005**

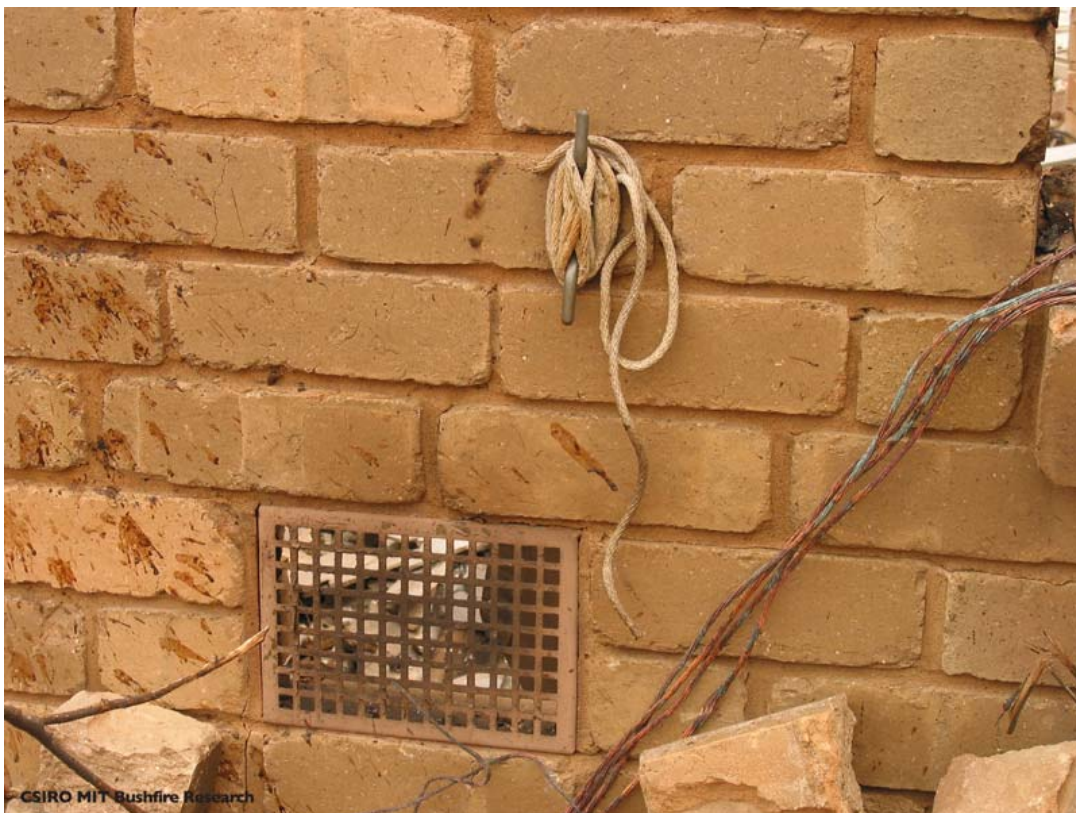
An example of an unprotected vent in a house surveyed in Duffy is shown in Figure 31.

**Figure 31. Typical unprotected vent**

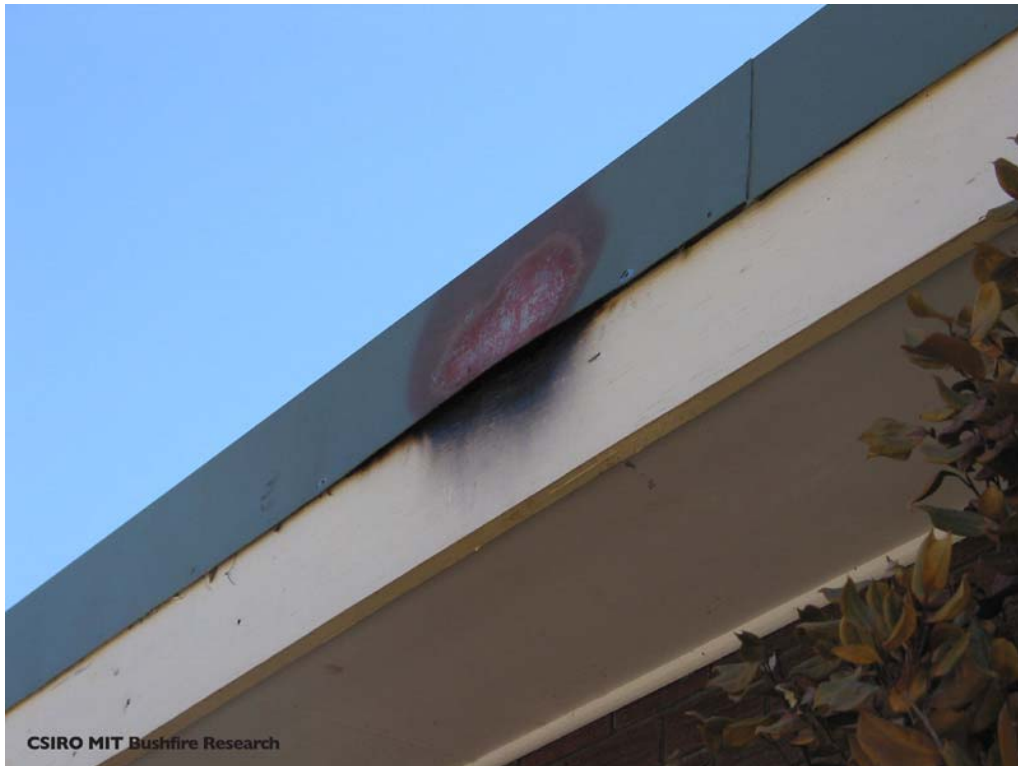
**Figure 35. Ember attack on poor fitting capping**

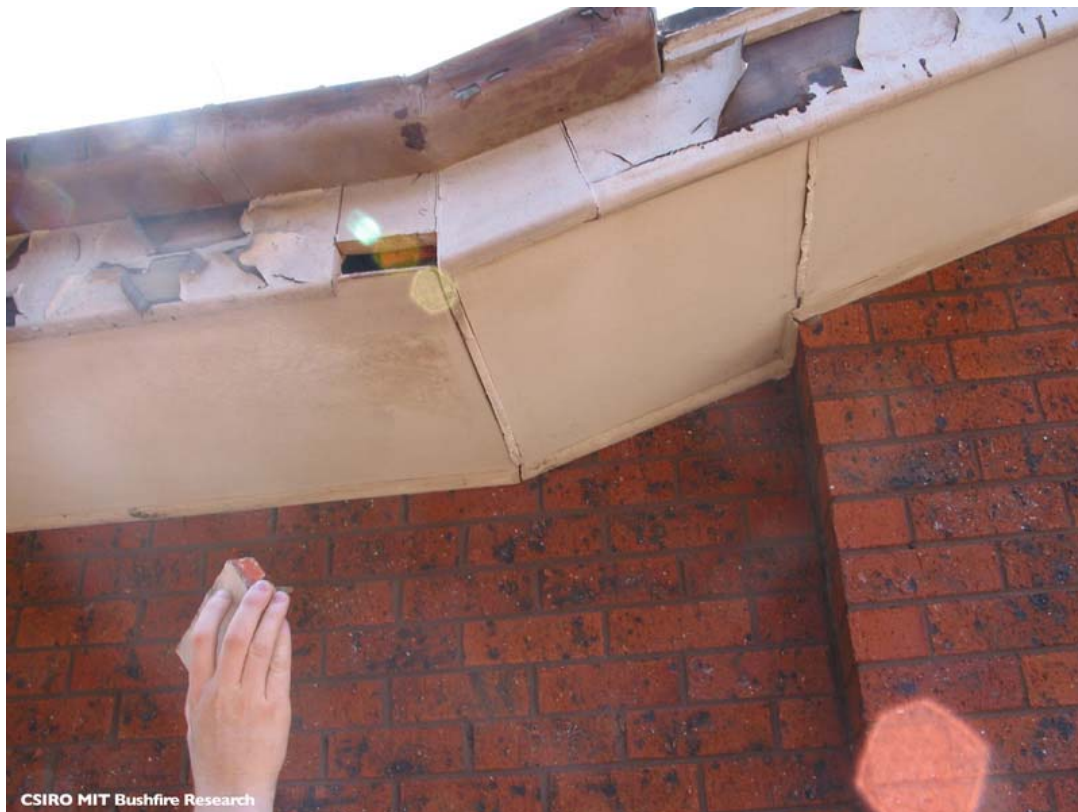
**Figure 36. Eaves damage due to radiant heat from adjacent fence and vegetation**

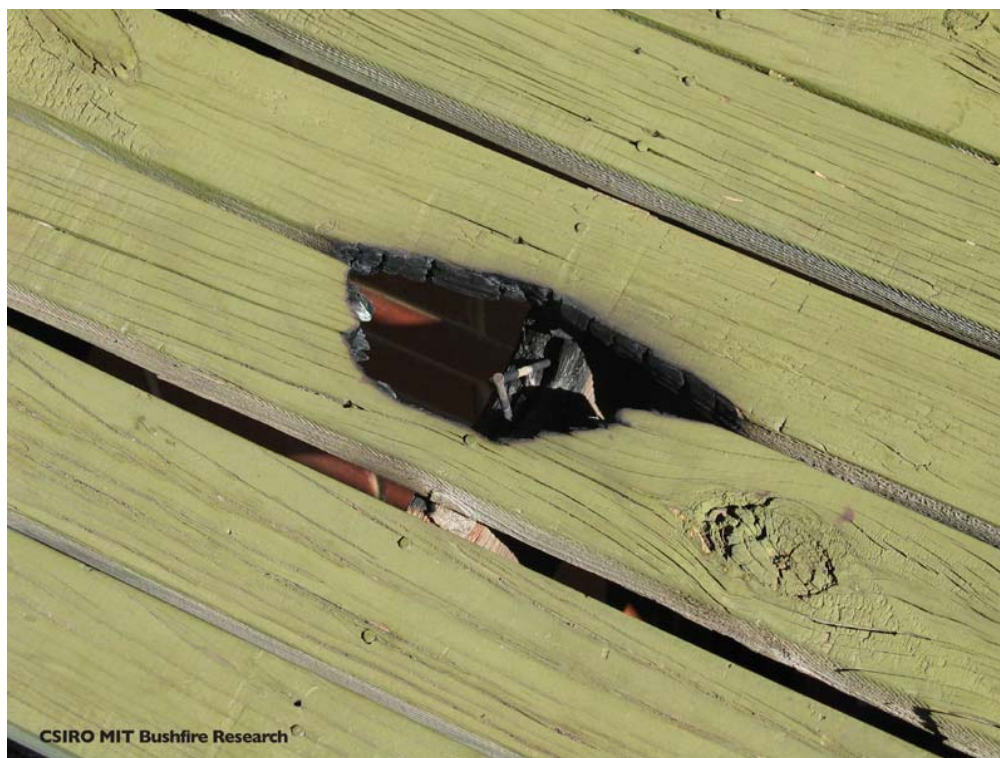
Of the houses in the surveyed area, 69% either had no deck or had non-combustible decks (Figure 37). A number of examples of timber deck ignitions that were suppressed by occupant activity were noted in the survey (see Figure 38).

**Figure 38. Ember attack on deck (with intervention)**

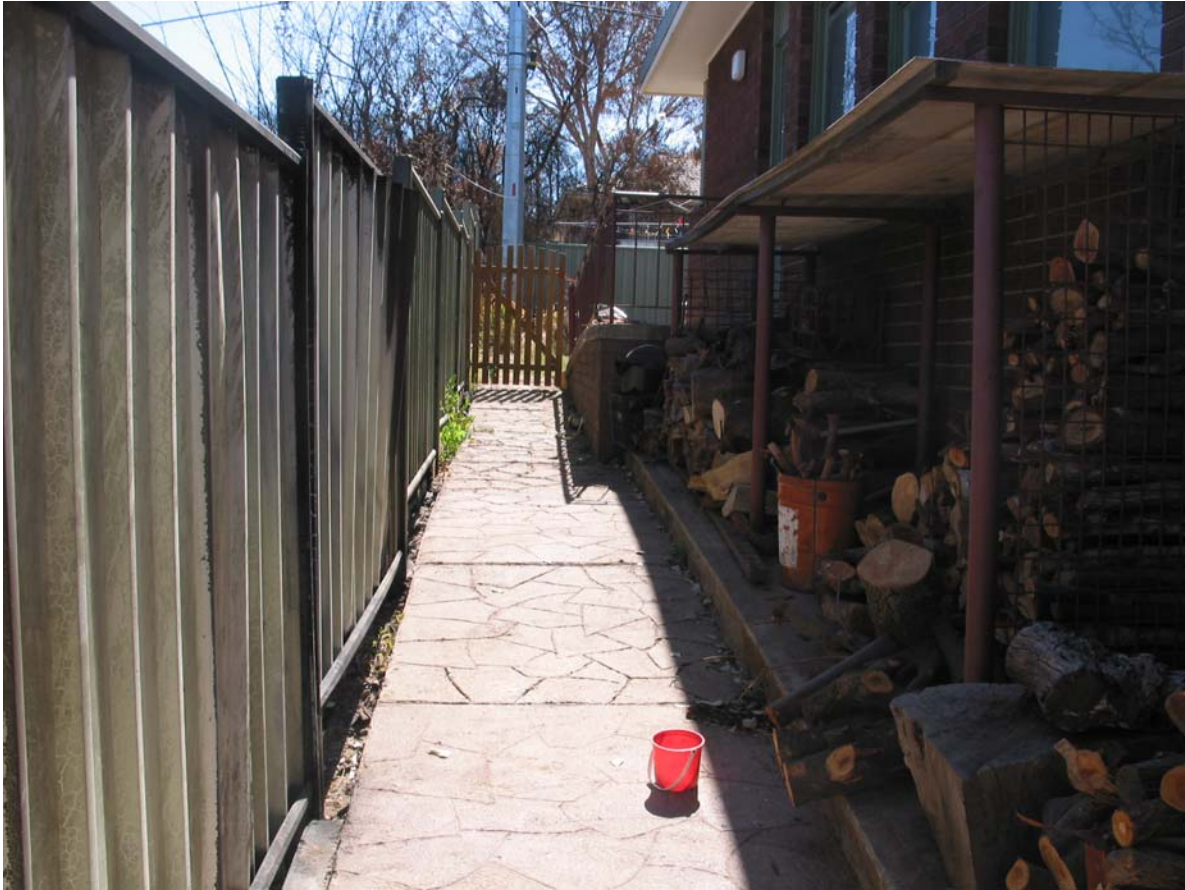
**Figure 47. Benefits of non combustibile fencing**
