**INVESTIGATION OF  
BUSHFIRE ATTACK MECHANISMS  
RESULTING IN HOUSE LOSS IN THE  
ACT BUSHFIRE 2003**

**Bushfire CRC Report**

**April 2005**

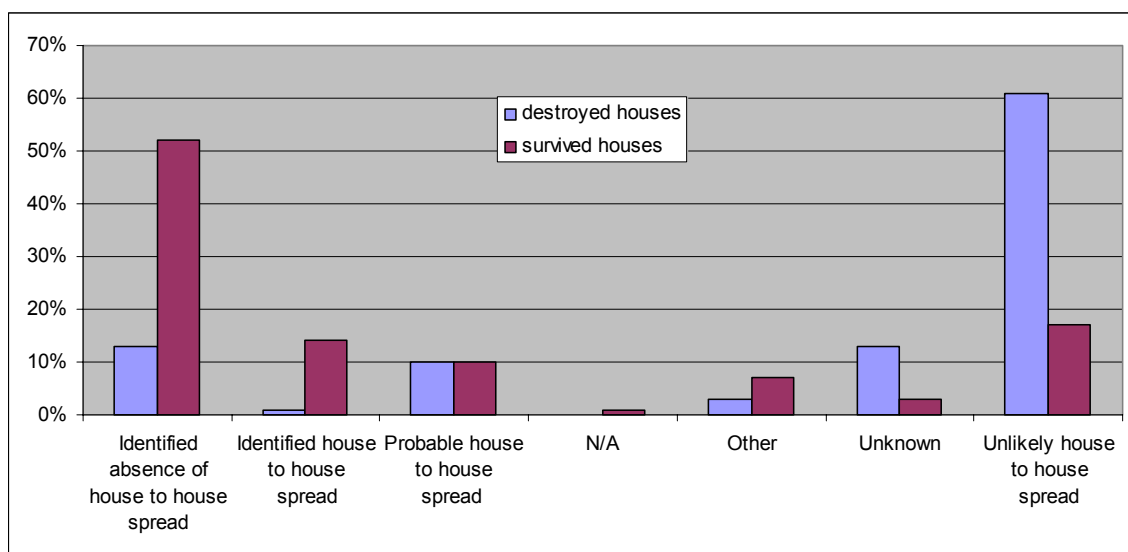
**Figure 14. Identification of house-to-house fire spread in Duffy**

House-to-house ignition played an important role after the passage of the fire front in Canberra; the ignitions were due to burning debris from house on fire, direct flame contact or radiant heat (see Figure 14).

The initial vegetation and structural fires in Duffy created an even more concentrated and enduring ember attack for those homes further downwind. Some of the structural fires provided direct flame attack and radiation impact on adjacent structures also. These impacts persisted for hours rather than the few minutes it takes for a flame front to pass. This effect was exacerbated by the placement of relatively large houses on medium sized blocks, and the presence of timber fences and vegetation between the closely orientated structures (see Figure 16). For further detail on vegetation and other structure impact, see Section 8.

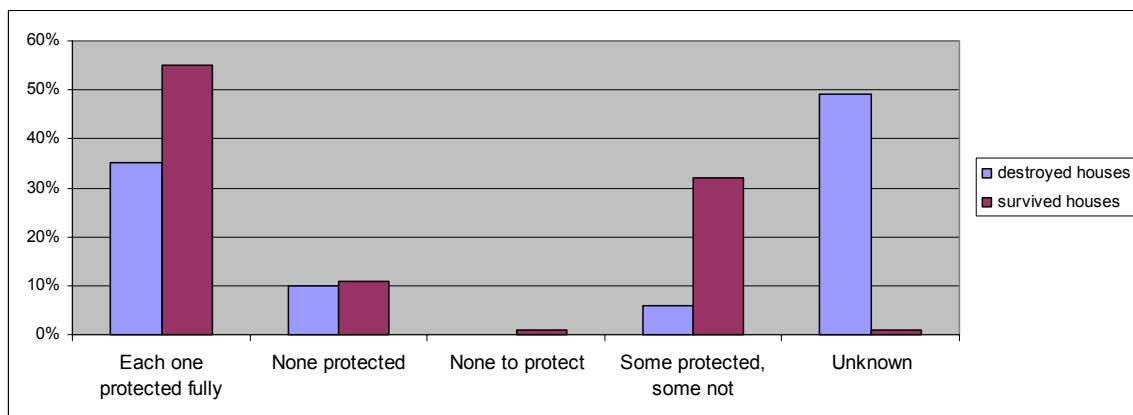
**Figure 24. Survey on door protection**

A method of reducing this effect is to either screen the door with a non-combustible screen door or use low- or non-combustible materials in the door assembly. The data collected in Duffy suggests some correlation between protected door openings and house survivability; however, this correlation is far from conclusive due to the large percentage of destroyed houses for which door protection was not determined (refer Figure 24). An important point to also make is that these screen doors are only effective if they are closed before, during and after the fire event.

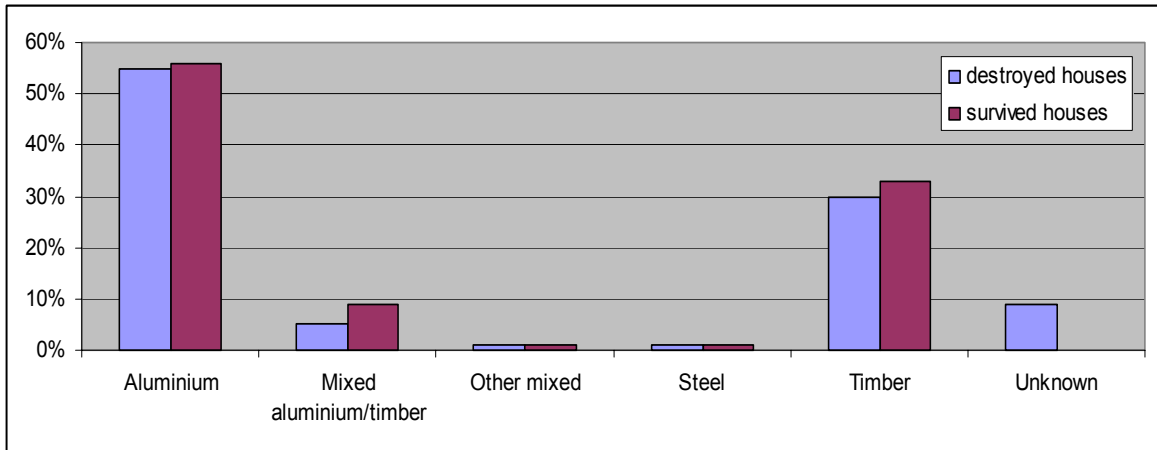
**Figure 26. Window frame material**

**In the houses surveyed, the window framing material was predominantly aluminium.** Figure 26 shows the percentage of each window frame type. There was insufficient data to identify a correlation between window frame type and risk of house loss.

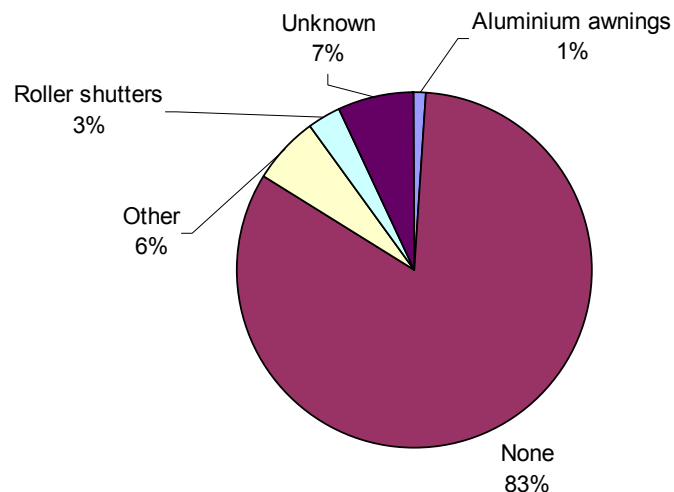
**Figure 27. Presence of shutters**

The houses surveyed in Duffy did not have shutters in the majority of the cases (see Figure 27).

Tight-fitting shutters can provide superior protection for windows as, when closed, they reduce the horizontal projection available for debris accumulation, remove one combustible surface in a re-entrant corner, and provide a radiation and ember barrier. Shutters, however, need to be closed to be effective. Optimum protection is provided by shutters (hinged or roll-down) that are made from materials which are not combustible, such as aluminium or steel. As well as protecting the glazing, shutters usually cover and protect window sills. This is of considerable advantage in the case of timber window sills which, like all horizontal timber elements of a house, are vulnerable to ember ignition.

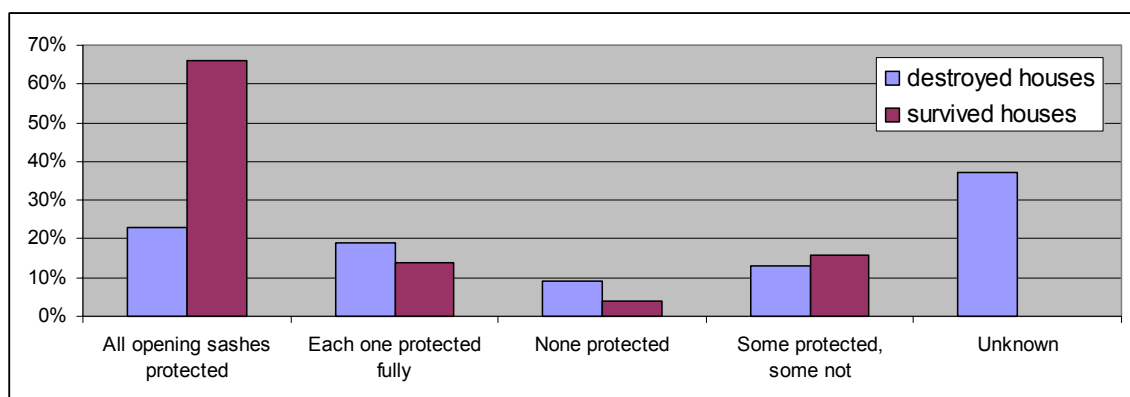
**Figure 32. Protection of windows on surviving houses**

AS 3959 specifies wire mesh screens on all opening windows including louvres. This reduces, to some extent, the levels of radiant heat impacting on the glazing and, if the glass cracks and falls away, it can help prevent windborne burning debris from entering the building. It is, however, less effective on the inside of hopper or awning windows, it is difficult to fit on non-opening sashes, especially with aluminium windows, and it impairs the view from picture windows unless special designs are adopted. Figure 32 shows that there is some indication that houses with protected opening sashes are less likely to be lost on a bushfires. However, the statistics are far from conclusive given that there is a statistical bias introduced by the large number of destroyed houses where window protection was not able to be identified.

Additional protection can be provided to window openings by flywire screens. It is important to note that the screening of all opening windows assists in reducing ember entry for partly open windows or windows that provide a greater than 2 mm gap when in a closed position. When screens are fitted to all windows, they reduce the radiation incident on the glazing and provide some ember protection in the event of the glass breaking.

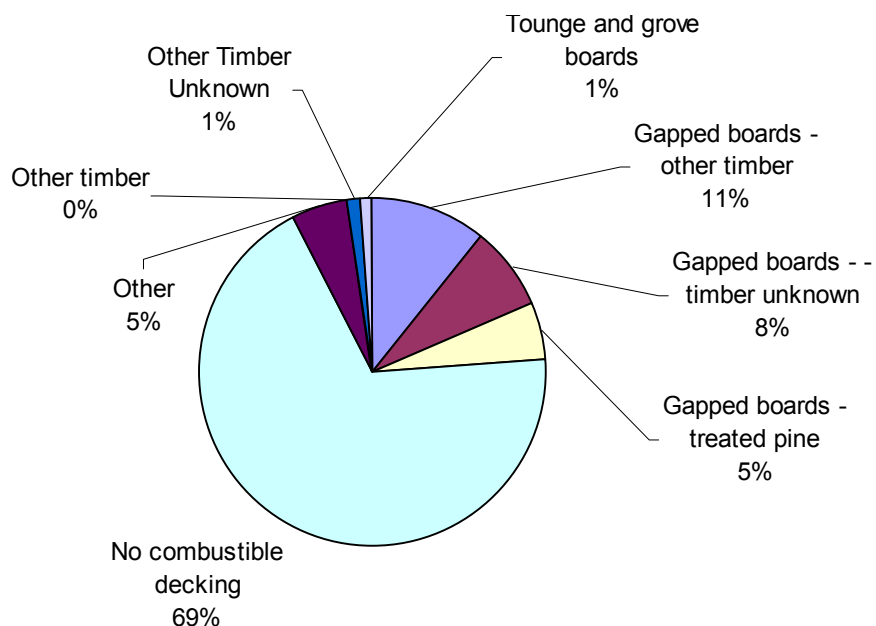
**Figure 37. Principal decking material**

Of the houses in the surveyed area, 69% either had no deck or had non-combustible decks (Figure 37). A number of examples of timber deck ignitions that were suppressed by occupant activity were noted in the survey (see Figure 38).

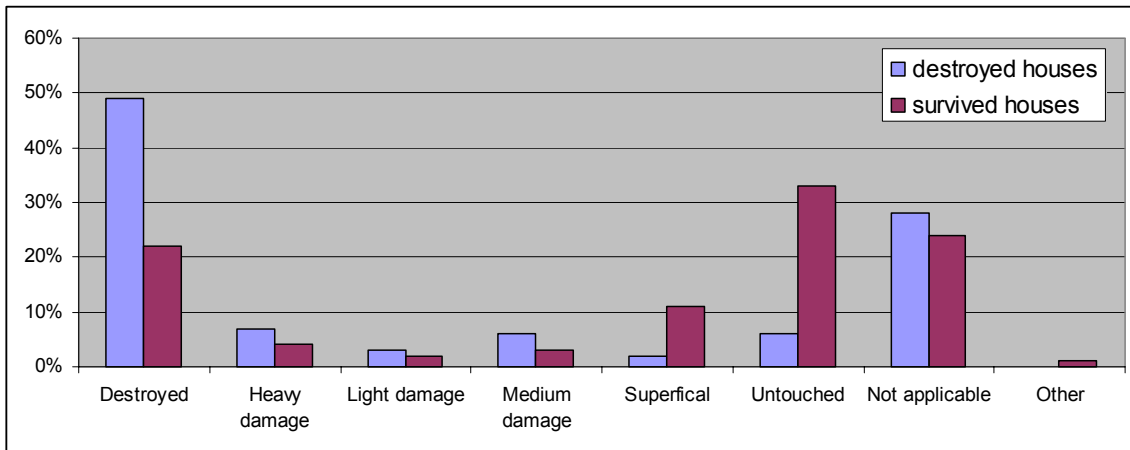
**Figure 40. Degree of damage of the first detached outbuilding**

The survey highlighted the fact that outbuildings are more readily lost compared to the main structures and represent a significant impact mechanism for main structure loss. In the survey area, 134 outbuildings were lost, while 106 houses were destroyed. Figure 40 identifies a strong correlation between destroyed outbuildings and destroyed houses. This correlation has obvious interdependency, as a burning house has the potential to ignite an adjoining outbuilding. Also, in areas of high ember attack, house loss and outbuilding loss are going to both be influenced by the increased ember attack. It is fair to conclude that a burning outbuilding presents an increased risk to the house, and that this contributes to the correlation seen in Figure 40.

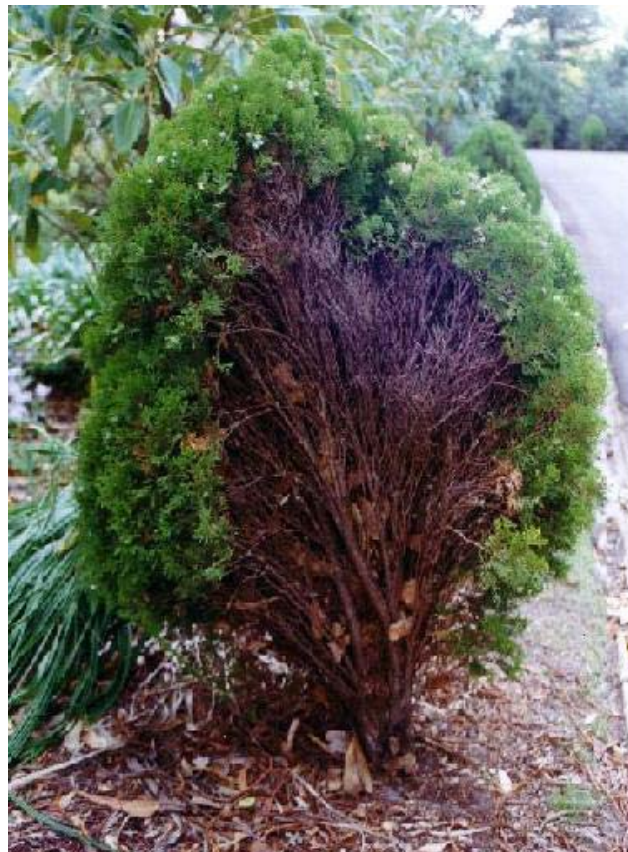
Certain types of vegetation are particularly susceptible to fire, for example cypress trees produce large quantities of dead material, and the intensity at which they burn may adversely impact on structures in the vicinity (see Figure 42 to Figure 44). The performance of this vegetation type is a direct observation of the survey initiative.

**Figure 42. Cypress tree (large quantities of dead material inside the tree, example not in Duffy area)**

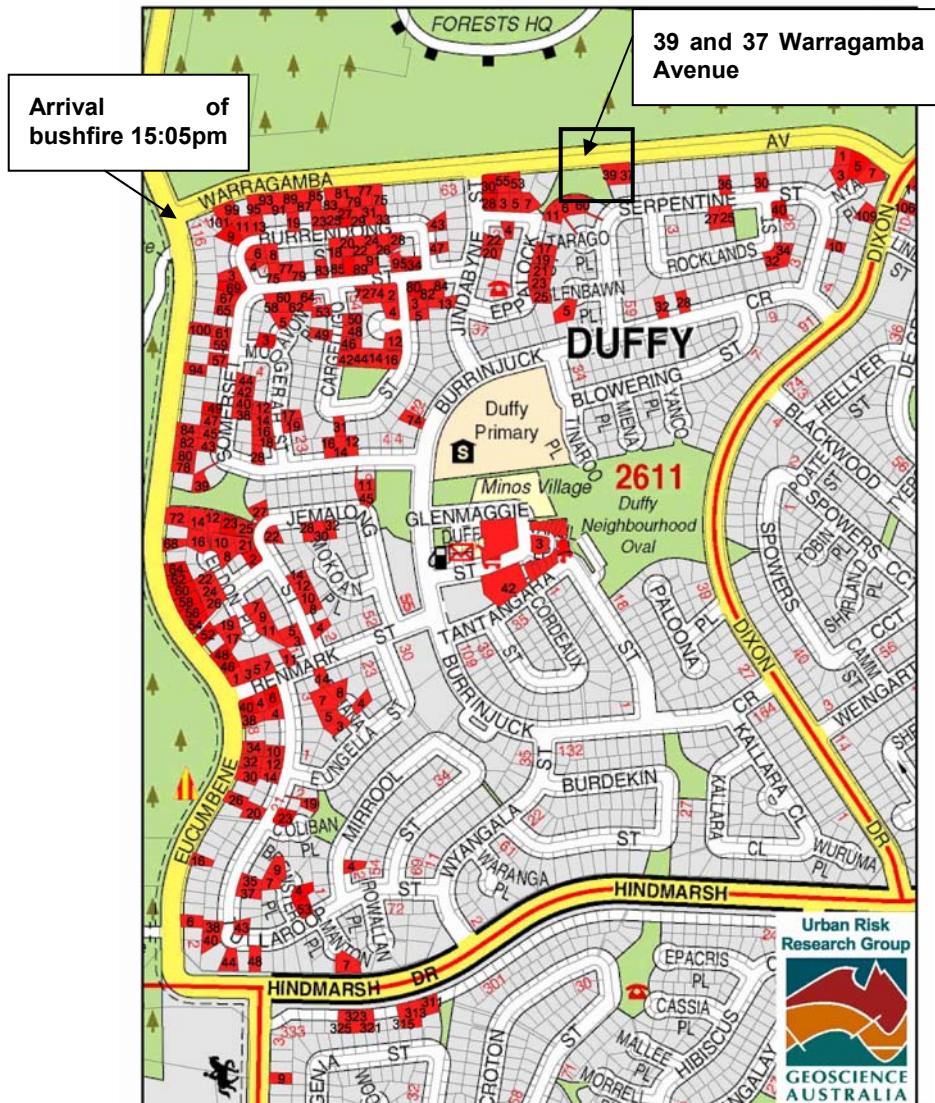
Figure 51 Fire passage in Duffy suburb

Phil Cheney mentioned that the fire reach the corner of Warragamba Ave and Eucumbene St Duffy at 15:05. By 15:45 the fire had entered the suburb of Duffy between Dixon Drive and Hindmarsh Drive (see ‘Origin and Development of the Bushfires that Spread Into the ACT, 8–18 January 2003’ by N.P. Cheney, Principal Research Scientist, CSIRO Forestry & Forest Products). See Figure 51 for details.
